# **Fire Endurance Tests of Steel Sandwich Panel Exterior Wall and Roof/Ceiling Constructions**

B. C. Son

December 1972

Final Report

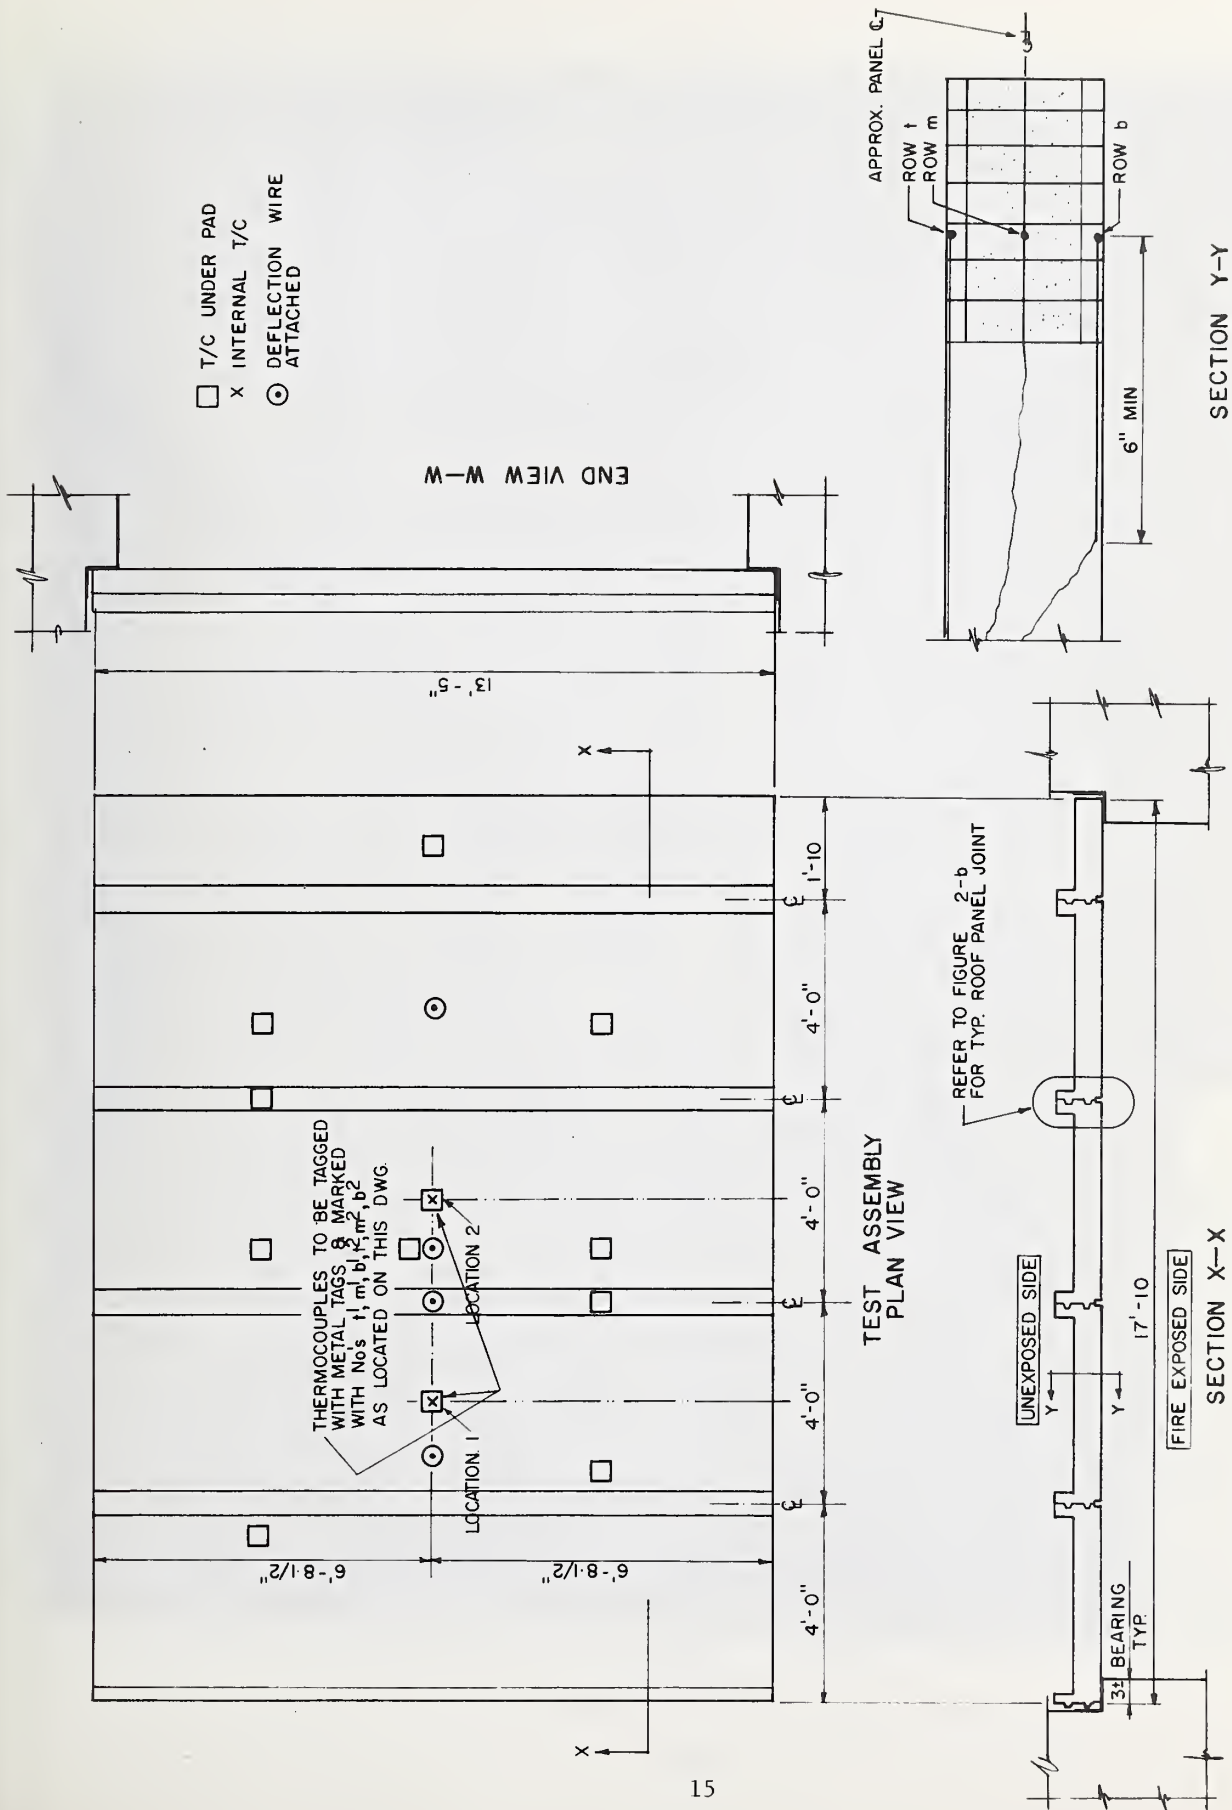
Figure 2-a Test Specimen and Location of thermocouples on Roof/Ceiling Assembly.

For the roof/ceiling assembly, 18 thermocouples were used, two on joints and 10 away from the joints on the unexposed surface, and six within two of the panels at three different levels. (See Figure 2-a.)

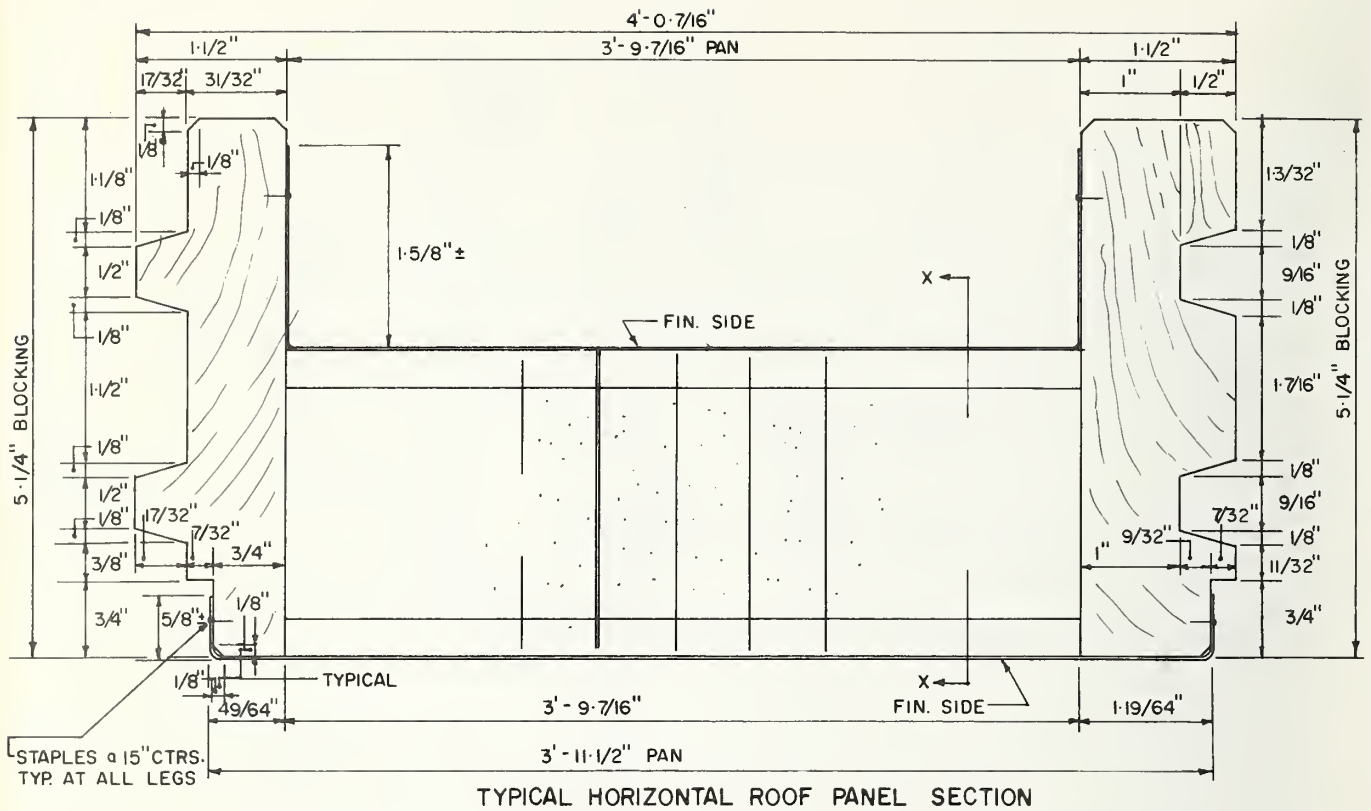
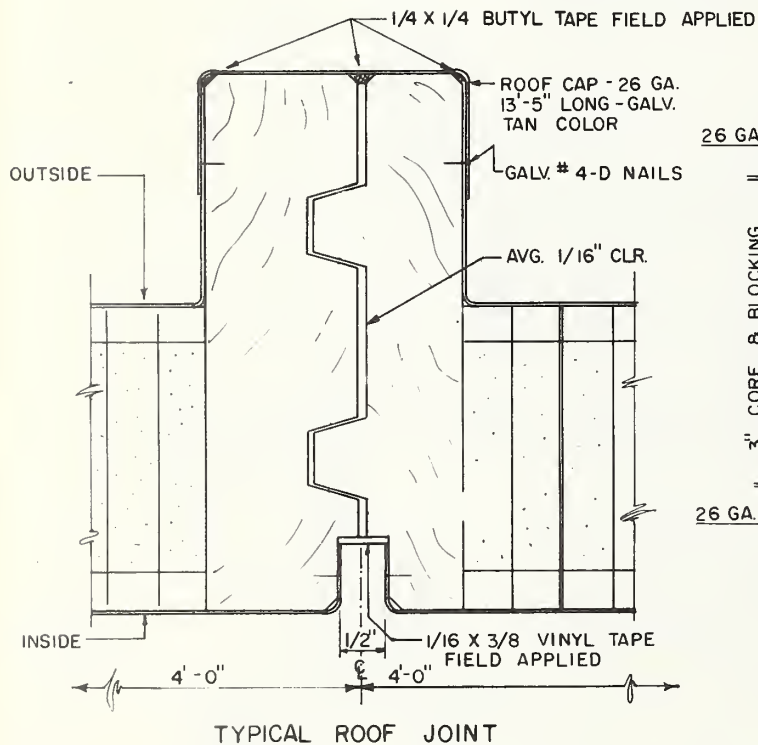
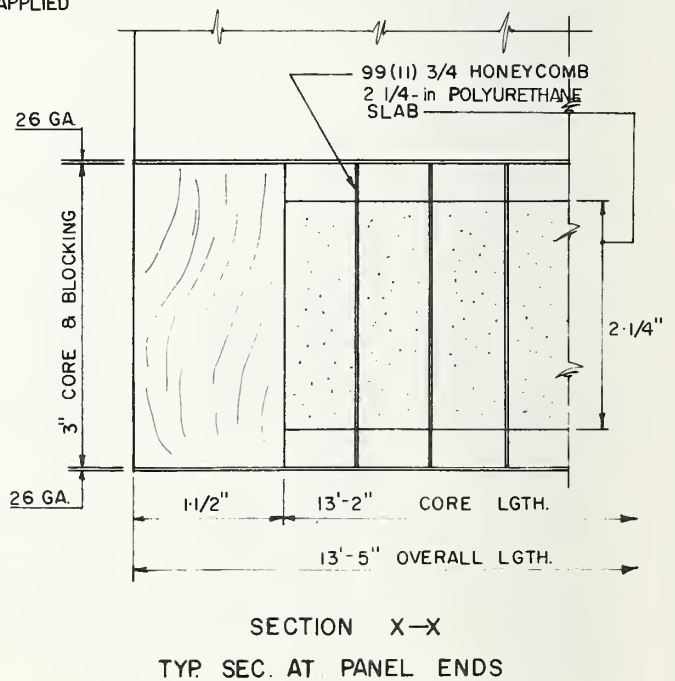
Figure 2-b Construction details of Roof/Ceiling panel.

The 17 ft wide 13 ft 5 in. long roof/ceiling assembly consisted of four 4 ft wide 13 ft 5 in. long panels and one 1 ft 10 in. wide 13 ft 5 in. long panel. Although similar in construction, the roof/ceiling assembly differed from that of the wall principally in the size of the wood edge closures, the thickness of the polyurethane foam, and the closing of the joints between panels. The floor/ceiling specimen and construction details are shown in Figures 2-a and 2-b.

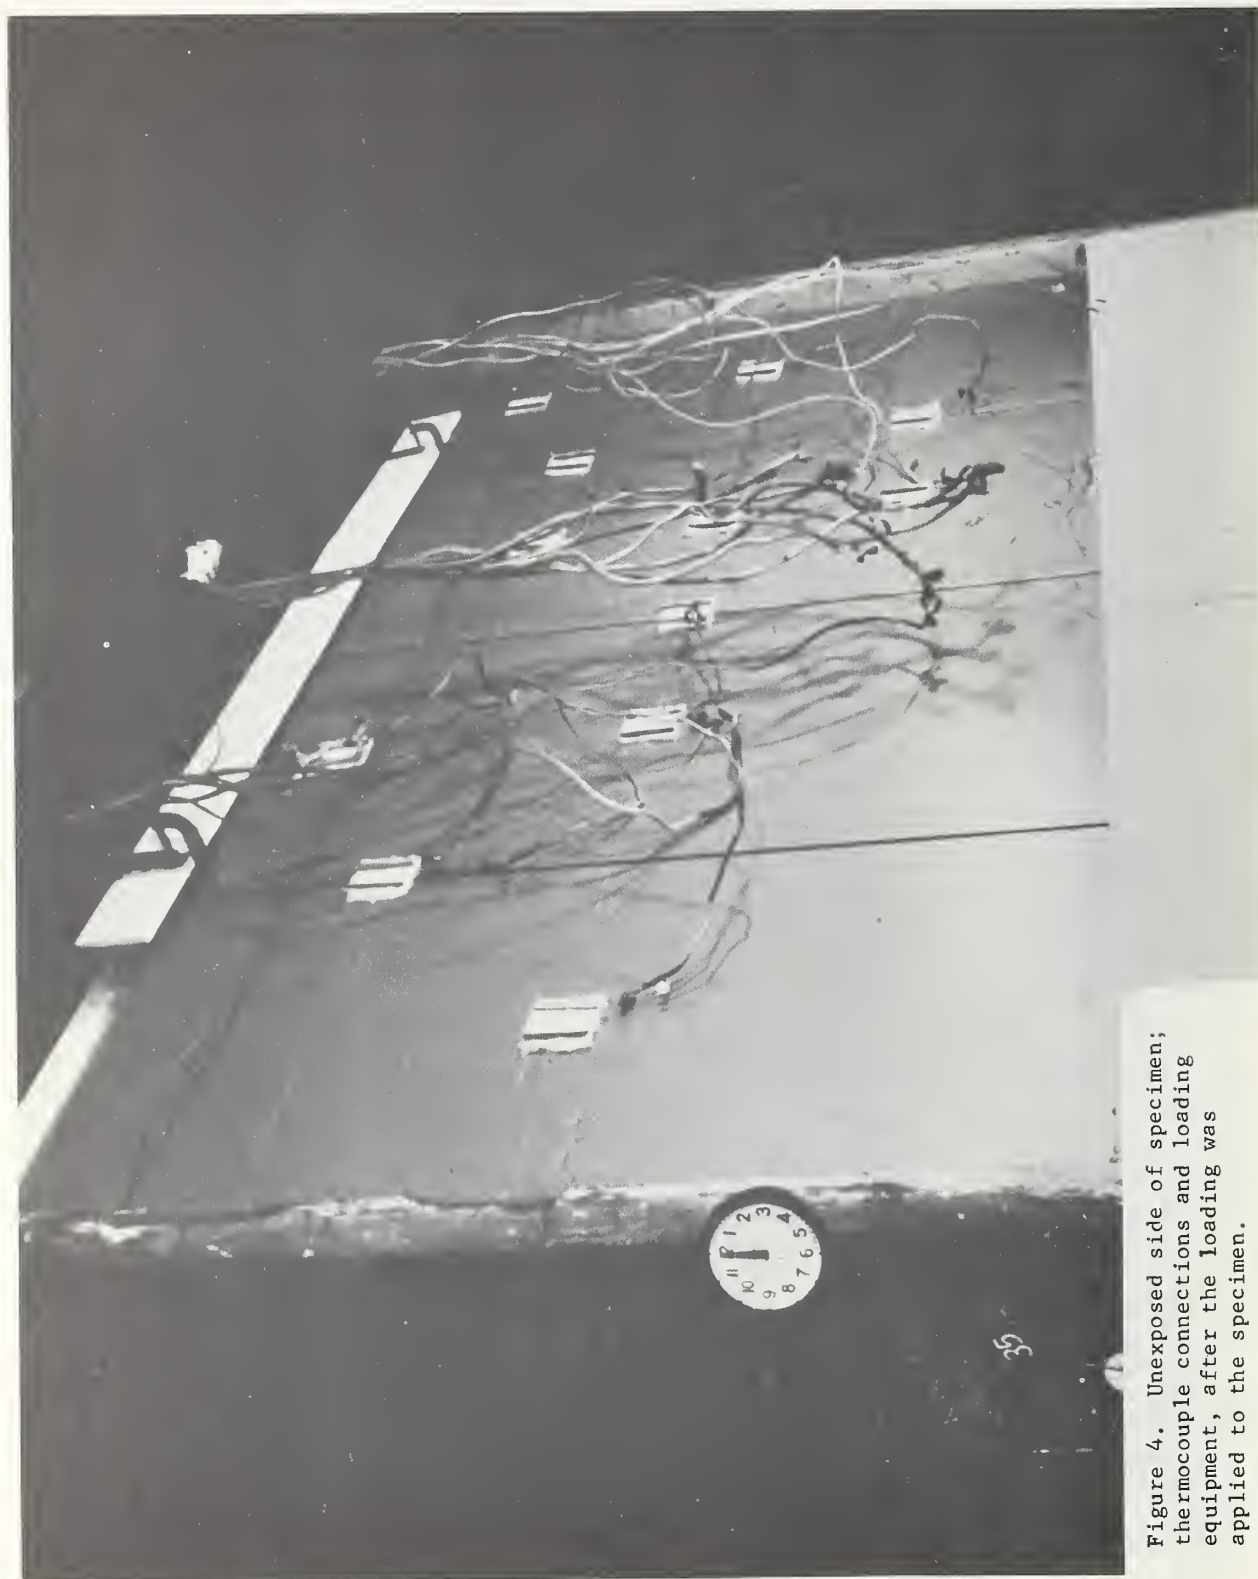
Figure 4. Unexposed side of specimen; thermocouple connections and loading equipment, after the loading was applied to the specimen.

A calculated load of 237 plf was applied to the wall specimen through four hydraulic jacks 5 min. before the test started. The loading represented the weight of the roof (30 plf) and the roof live load (207 plf) Figure 4 shows the unexposed surface of the wall, the thermocouple connections and the loading equipment with the test frame in place as a wall of the panel testing furnace.

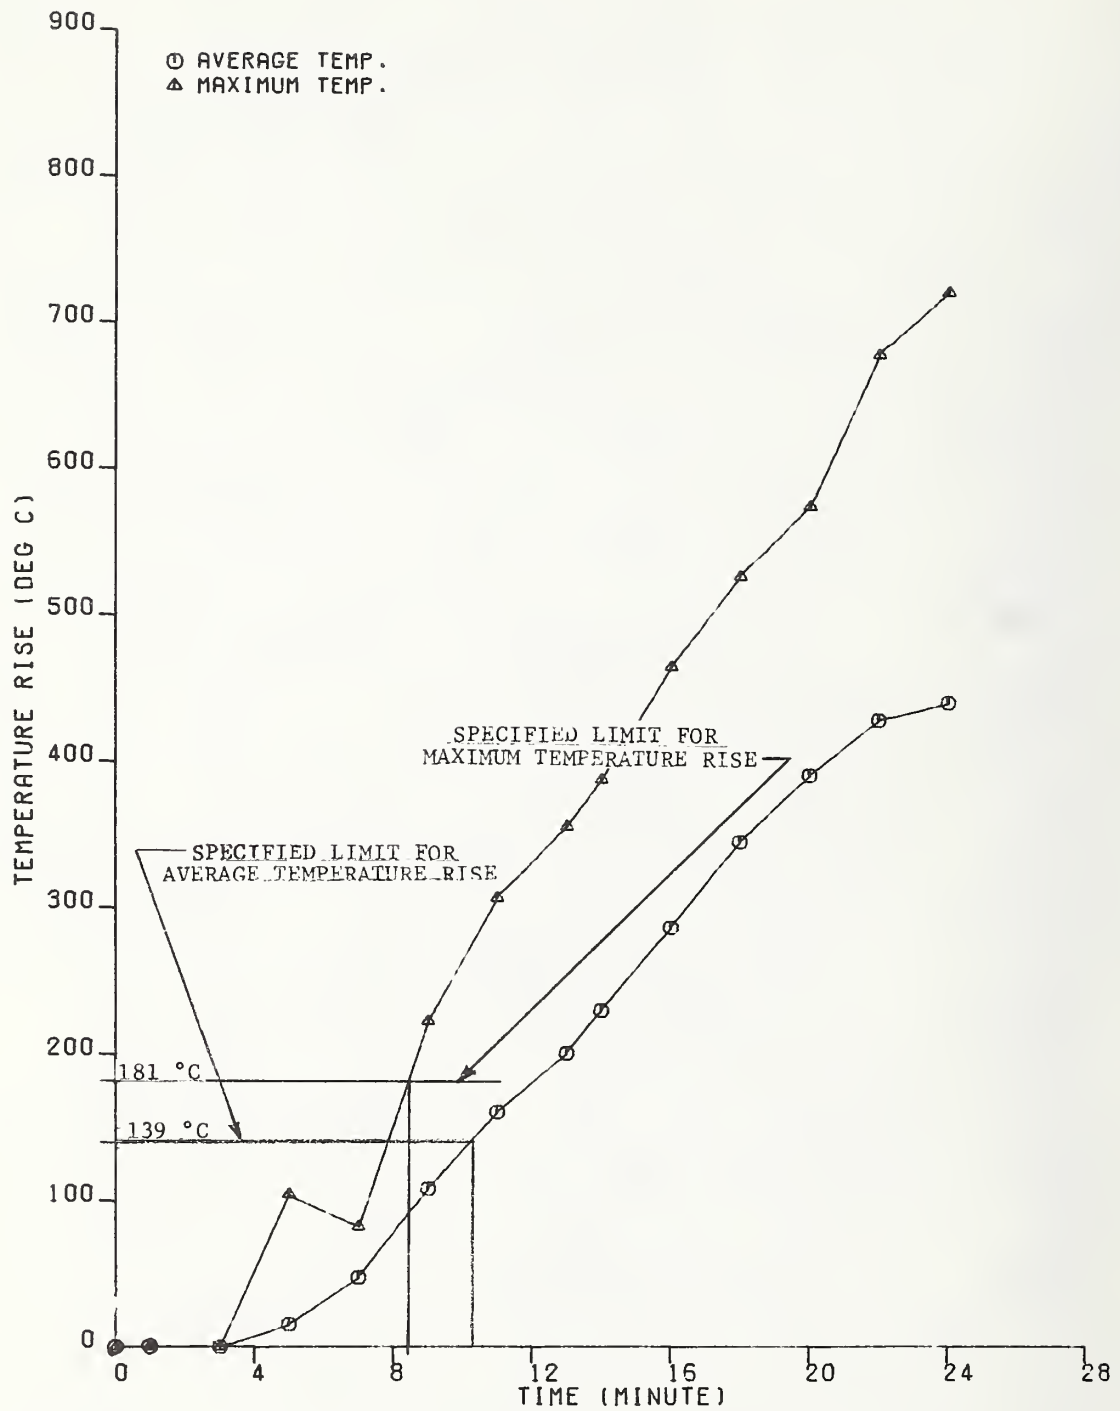
Figure 6.

The plotted results of the tests indicated as the average and one-point maximum temperature rises of all the thermocouples on the unexposed surfaces of the assemblies are shown in Figure 6 for the wall assembly and in Figure 7 for the roof/ceiling assembly. The average temperature profile across the wall and roof/ceiling assemblies are shown in Figures 8 and 9, respectively. Movement of the four panel wall assembly from the vertical plane is indicated in Figure 10. Figure 11 shows the deflections of the four measured points on the roof/ceiling.

MAXIMUM AND AVERAGE SURFACE TEMPERATURE Roof/Ceiling Assembly

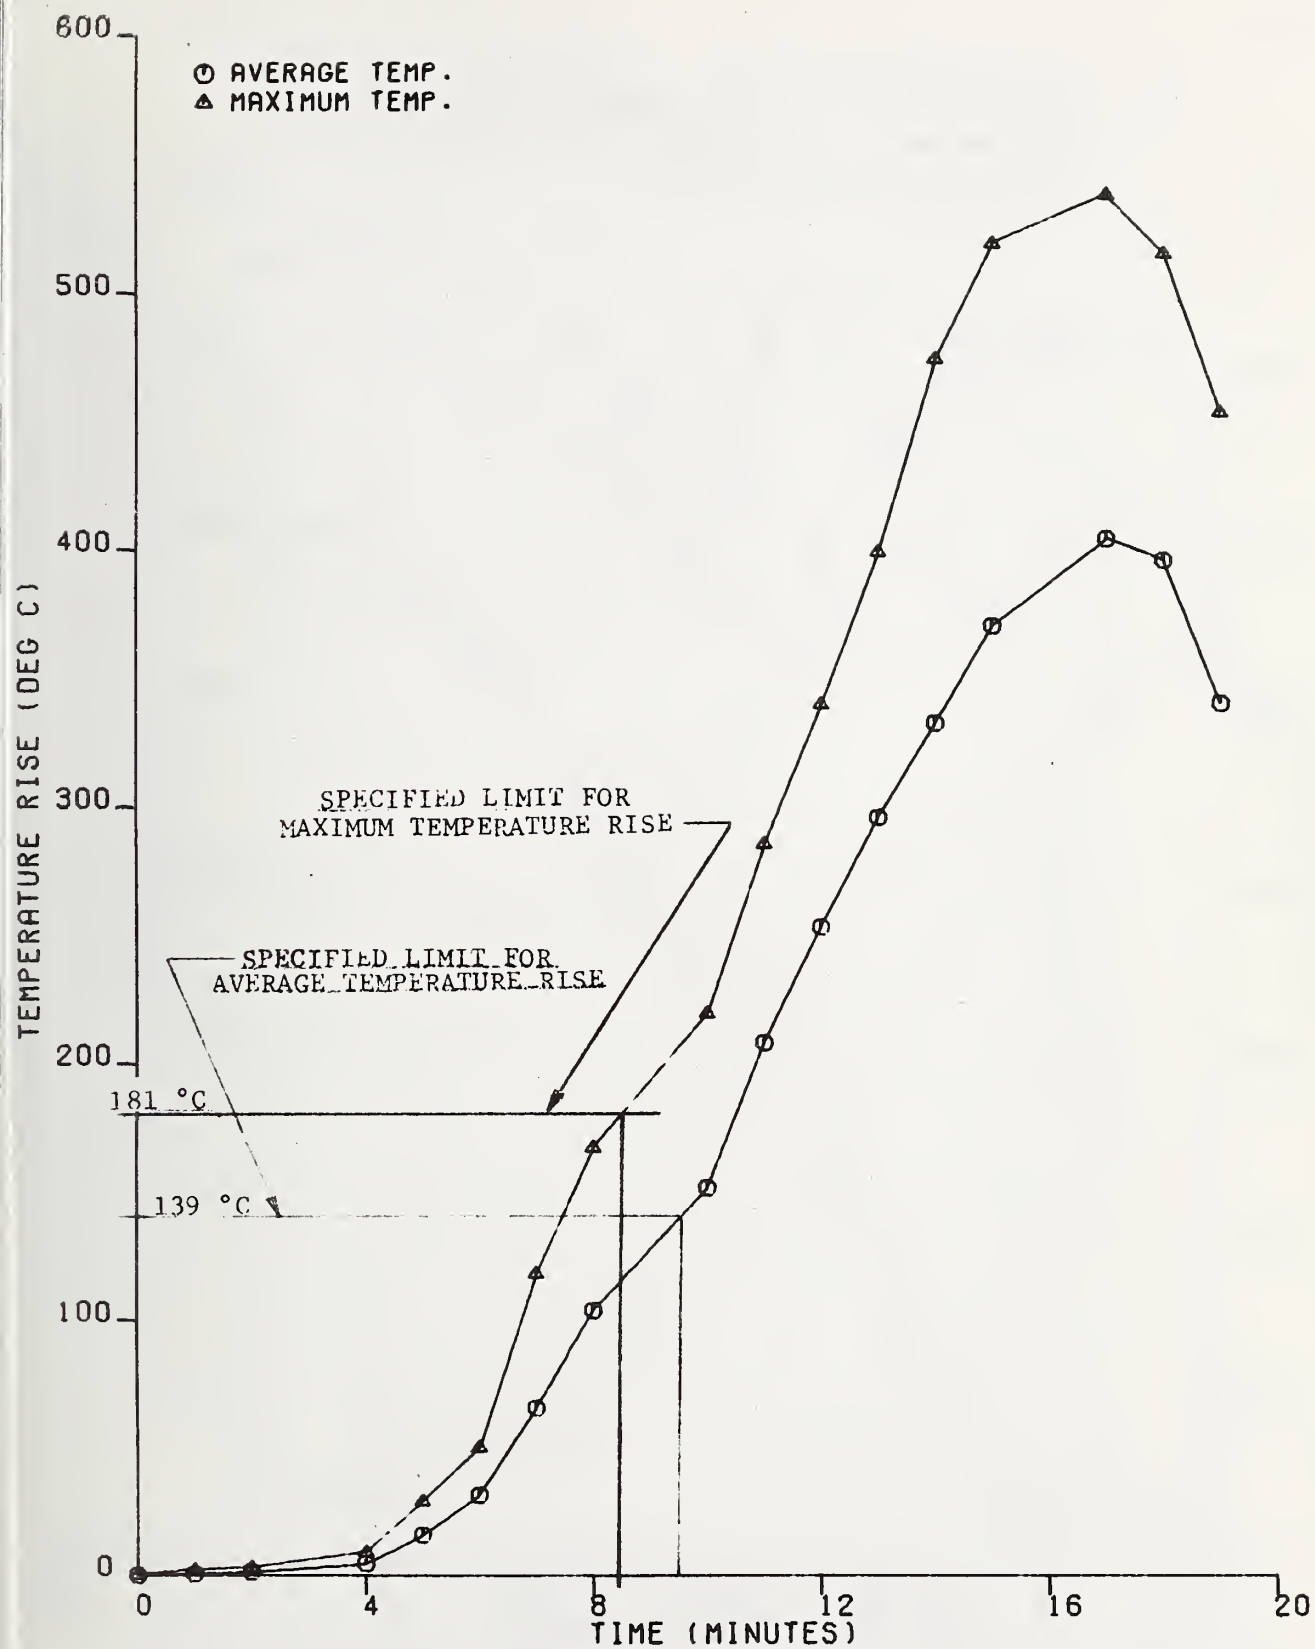
Figure 7.

MAXIMUM AND AVERAGE SURFACE TEMPERATURE RISE-Wall Assembly

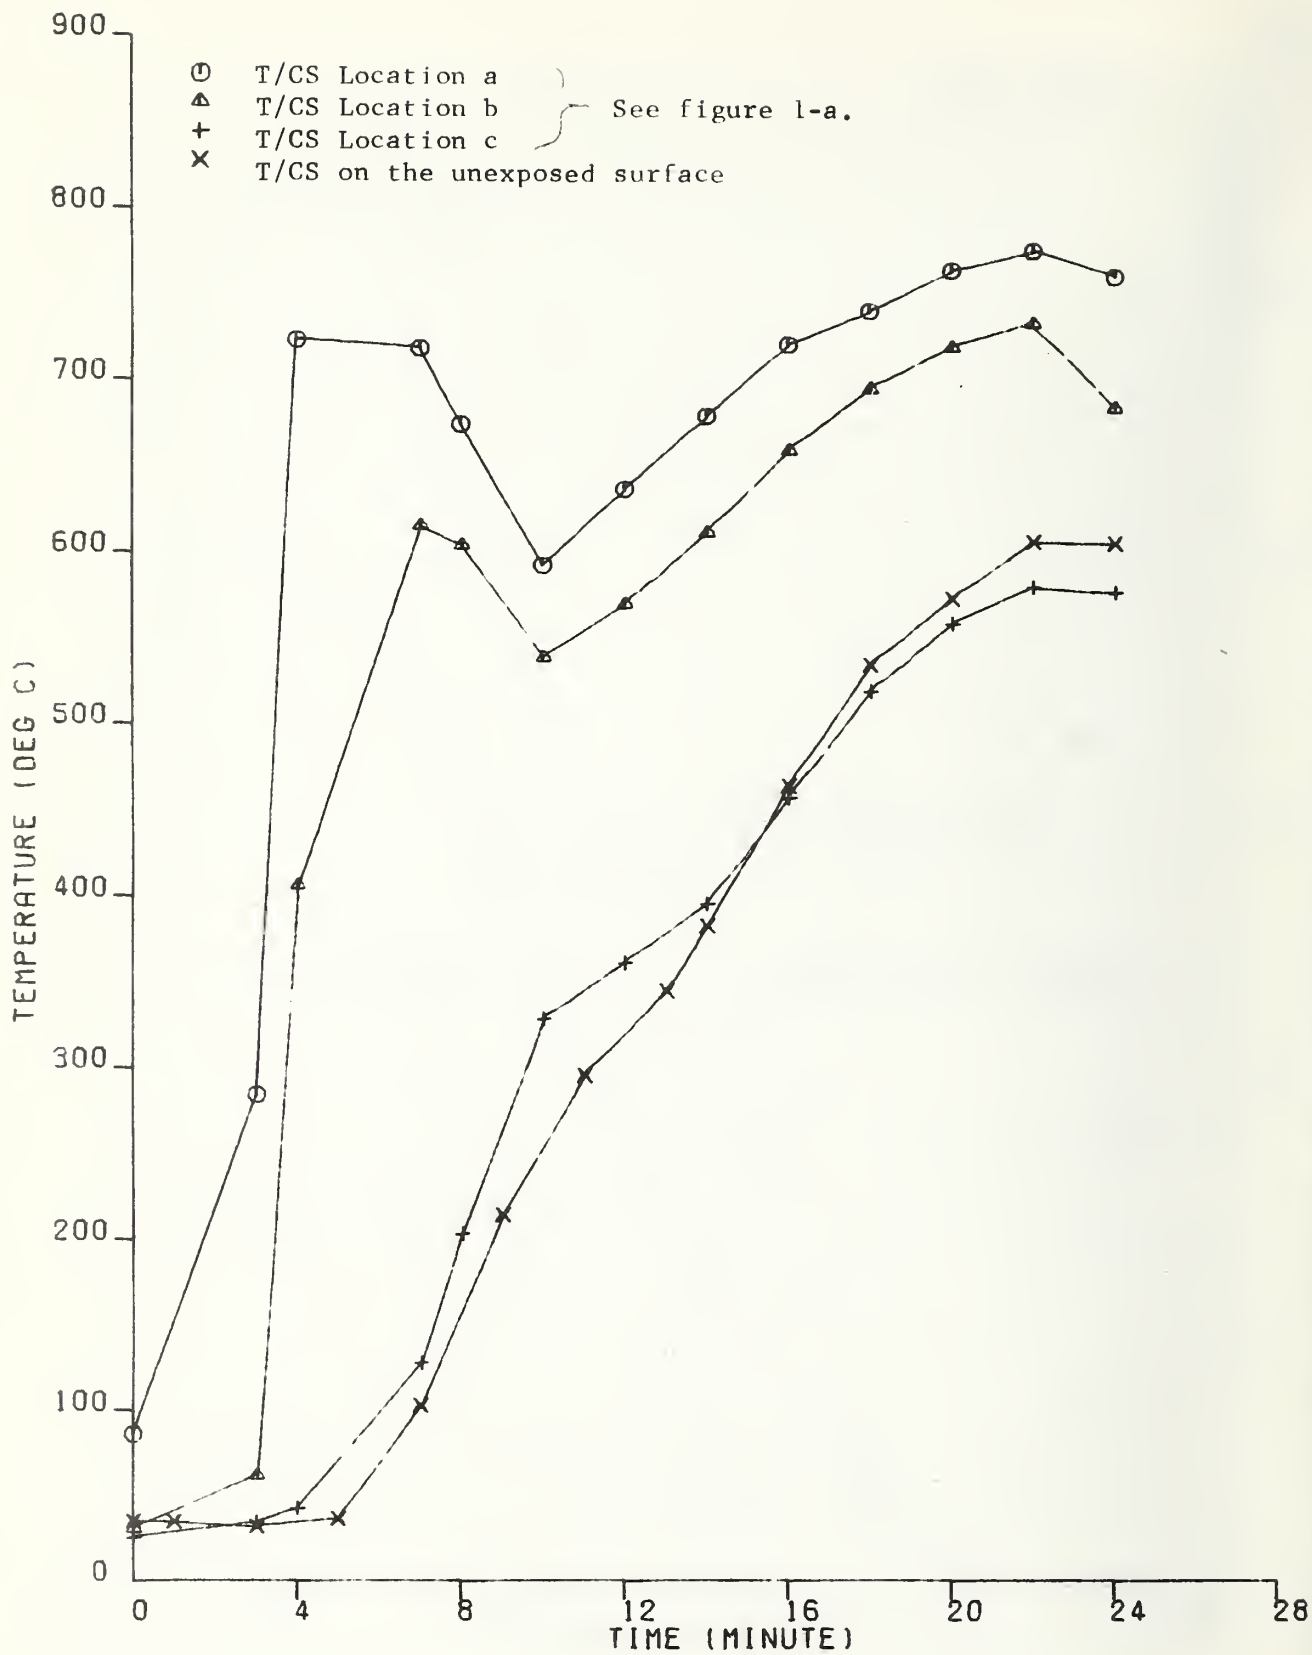
Figure 8

TEMPERATURE GRADIENT ACROSS THE WALL PANEL (TEST 489)

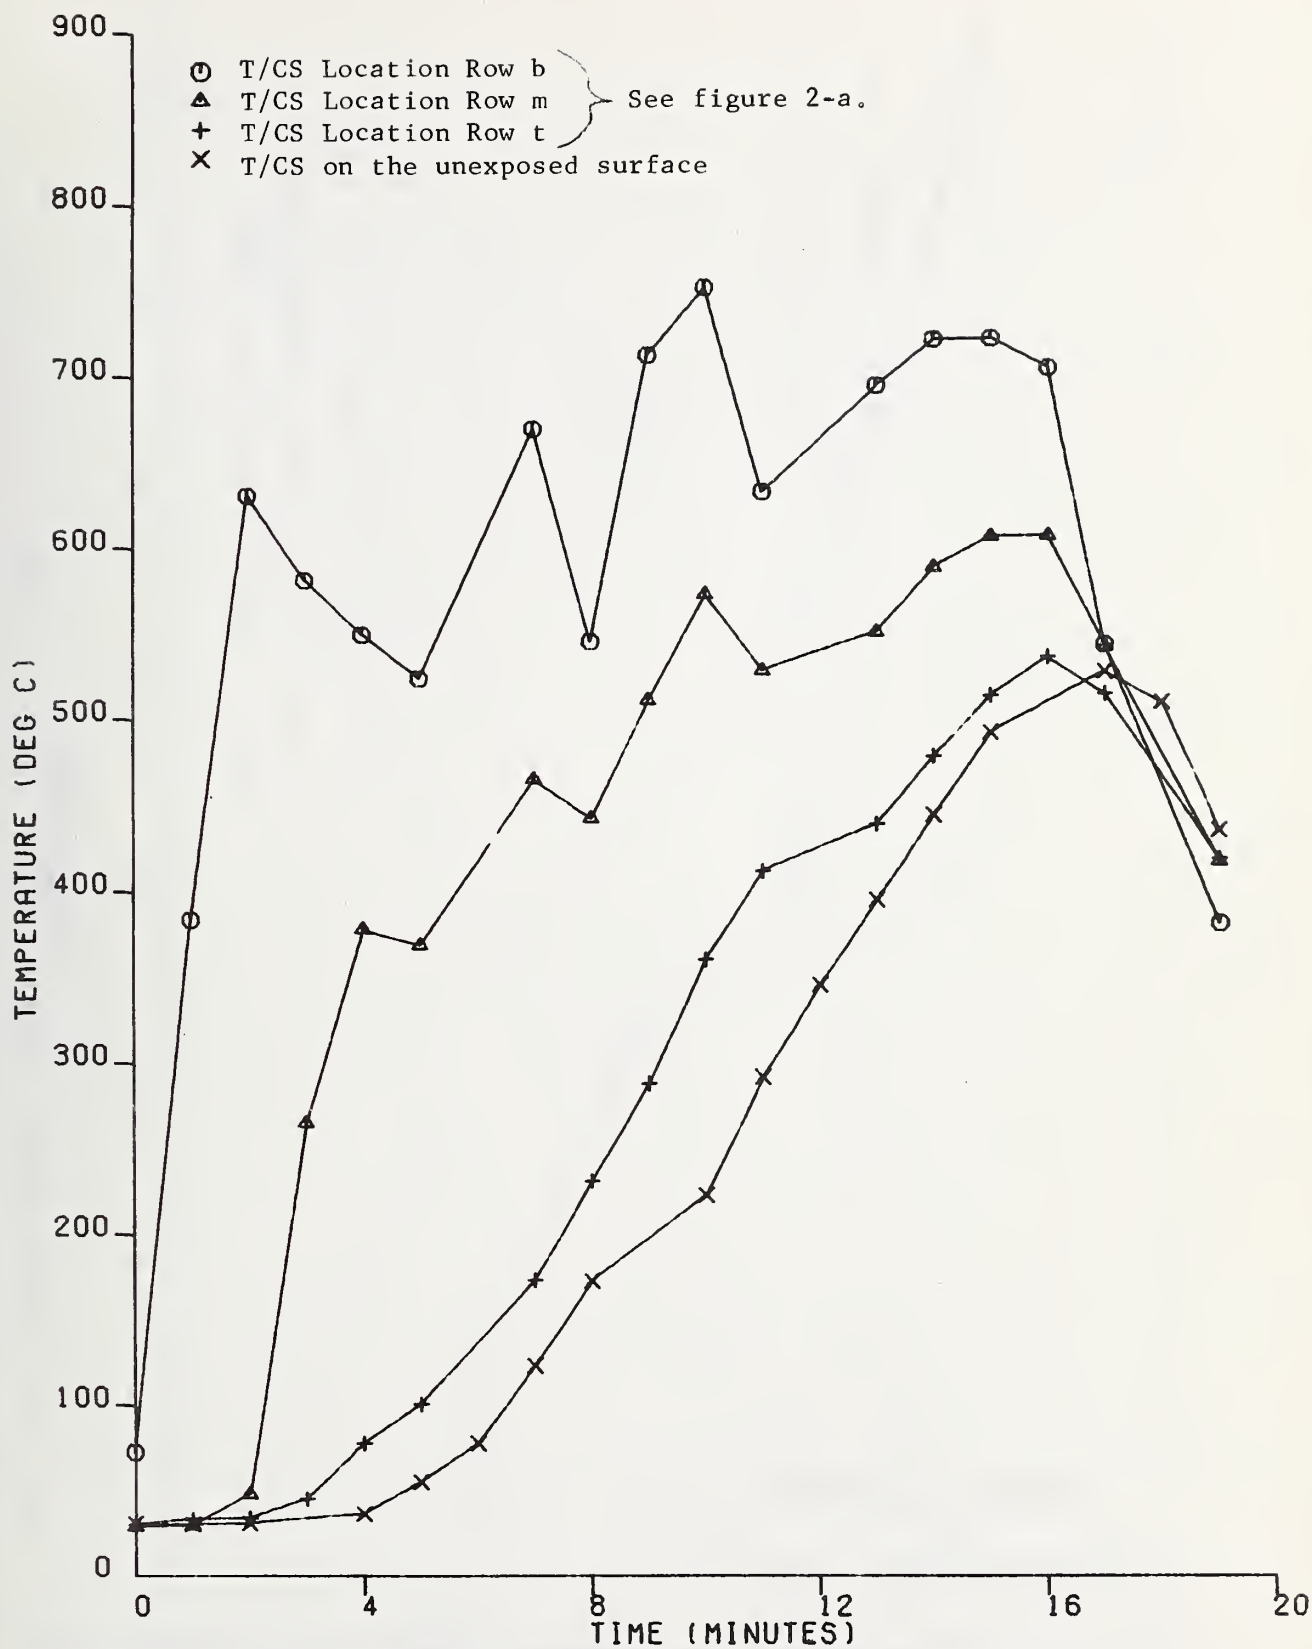
Figure 9.  
TEMPERATURE GRADIENT ACROSS THE FLOOR/CEILING ASSEMBLY (TEST 490)

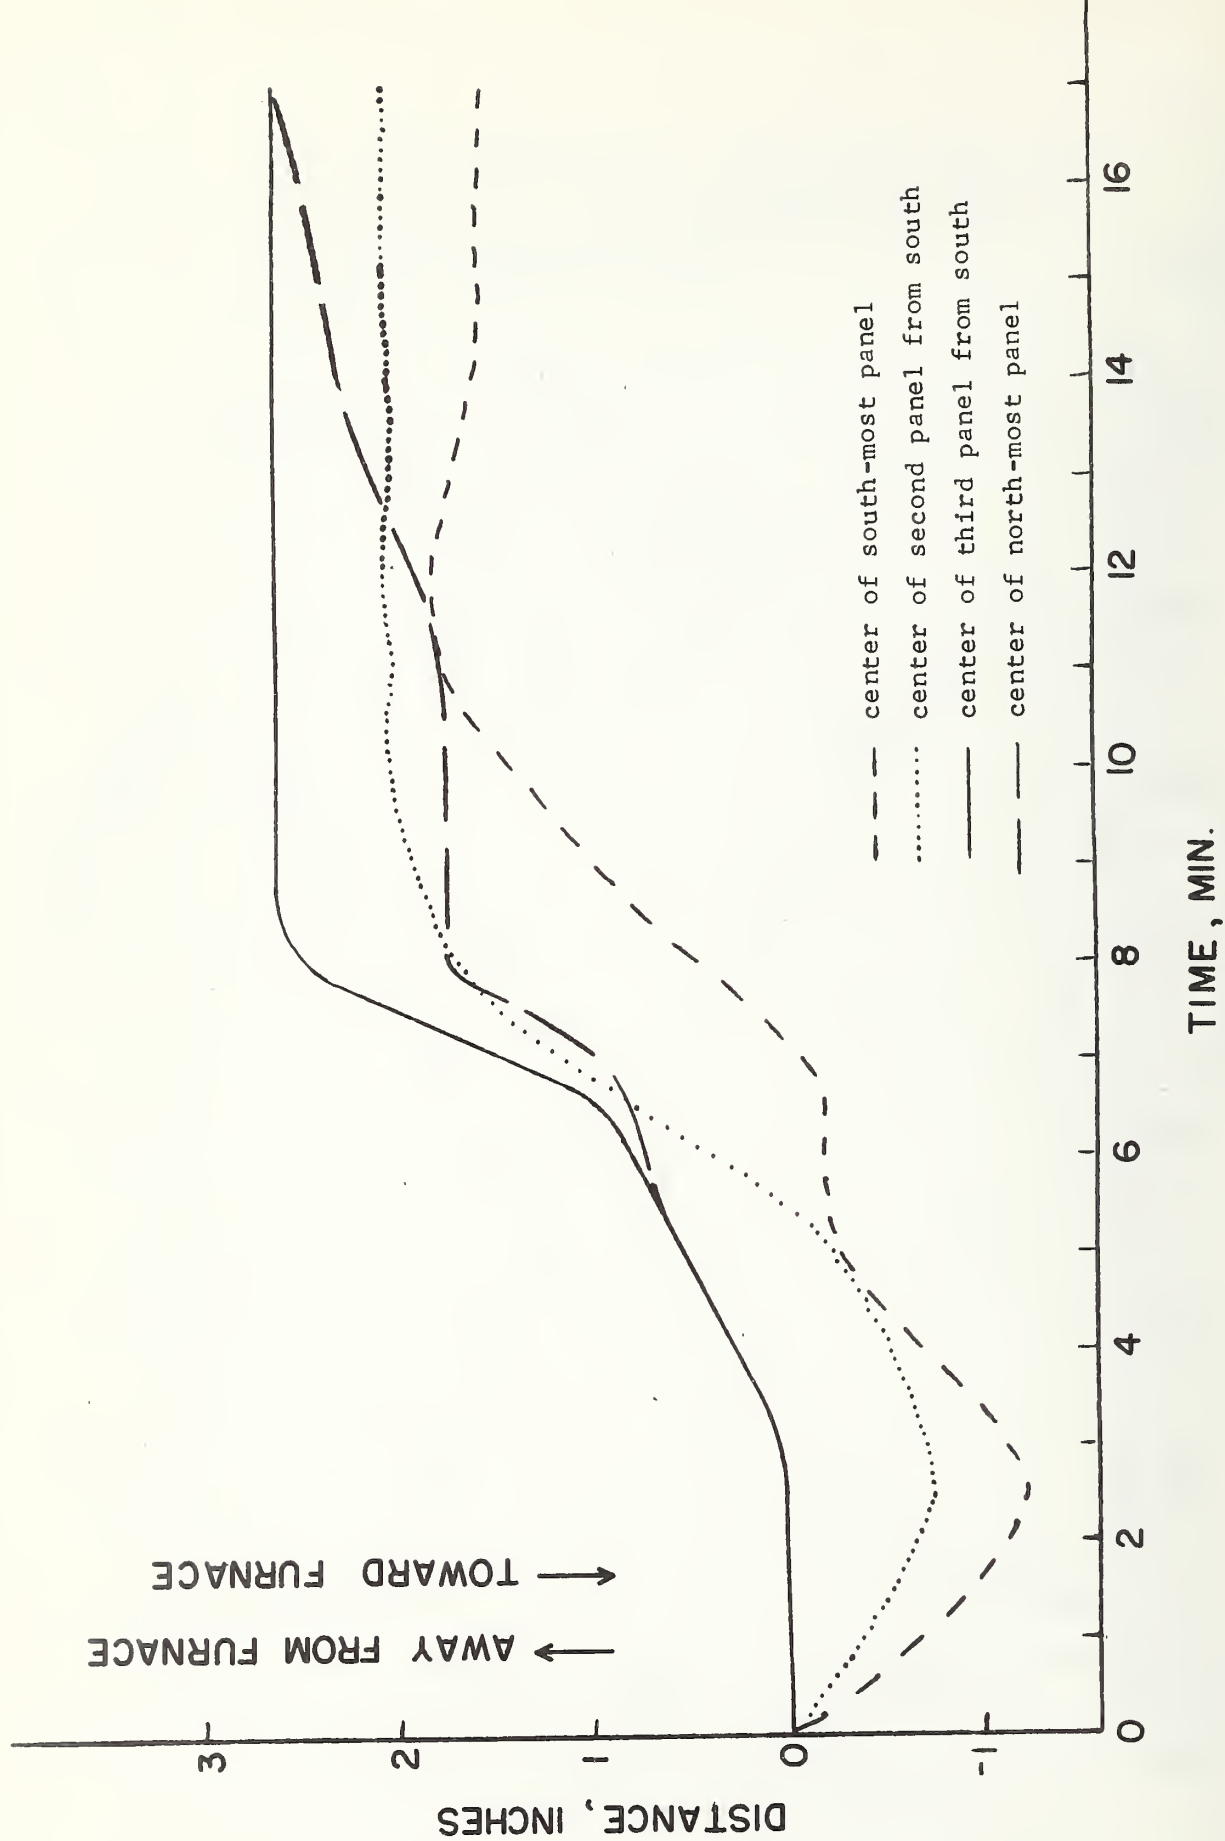
Figure 10. DEFLECTIONS ON THE UNEXPOSED SURFACE, WALL ASSEMBLY.

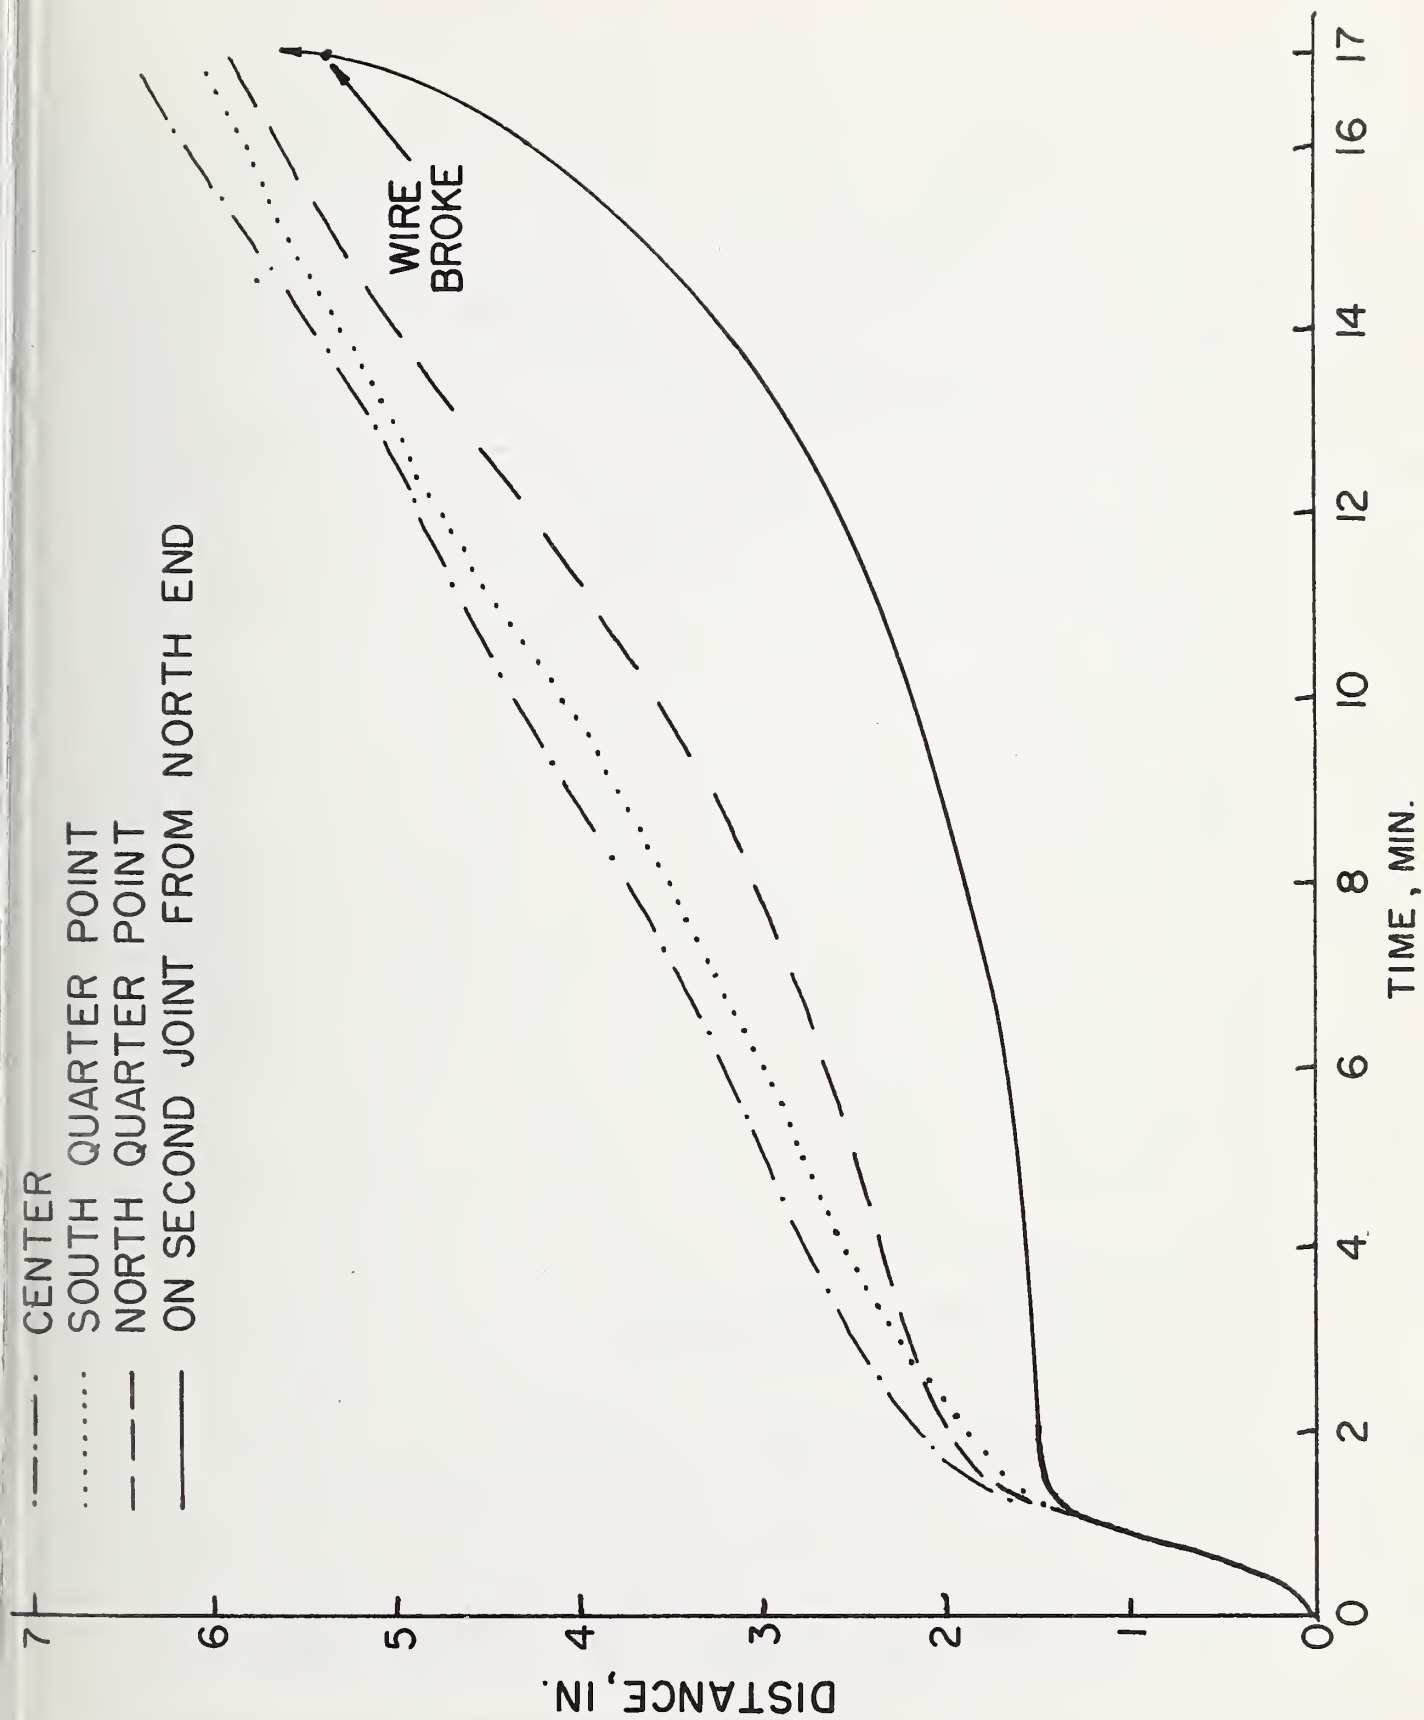
Figure 11. DEFLECTIONS OF THE 4 POINTS ON THE UNEXPOSED SURFACE. ROOF/CEILING ASSEMBLY.

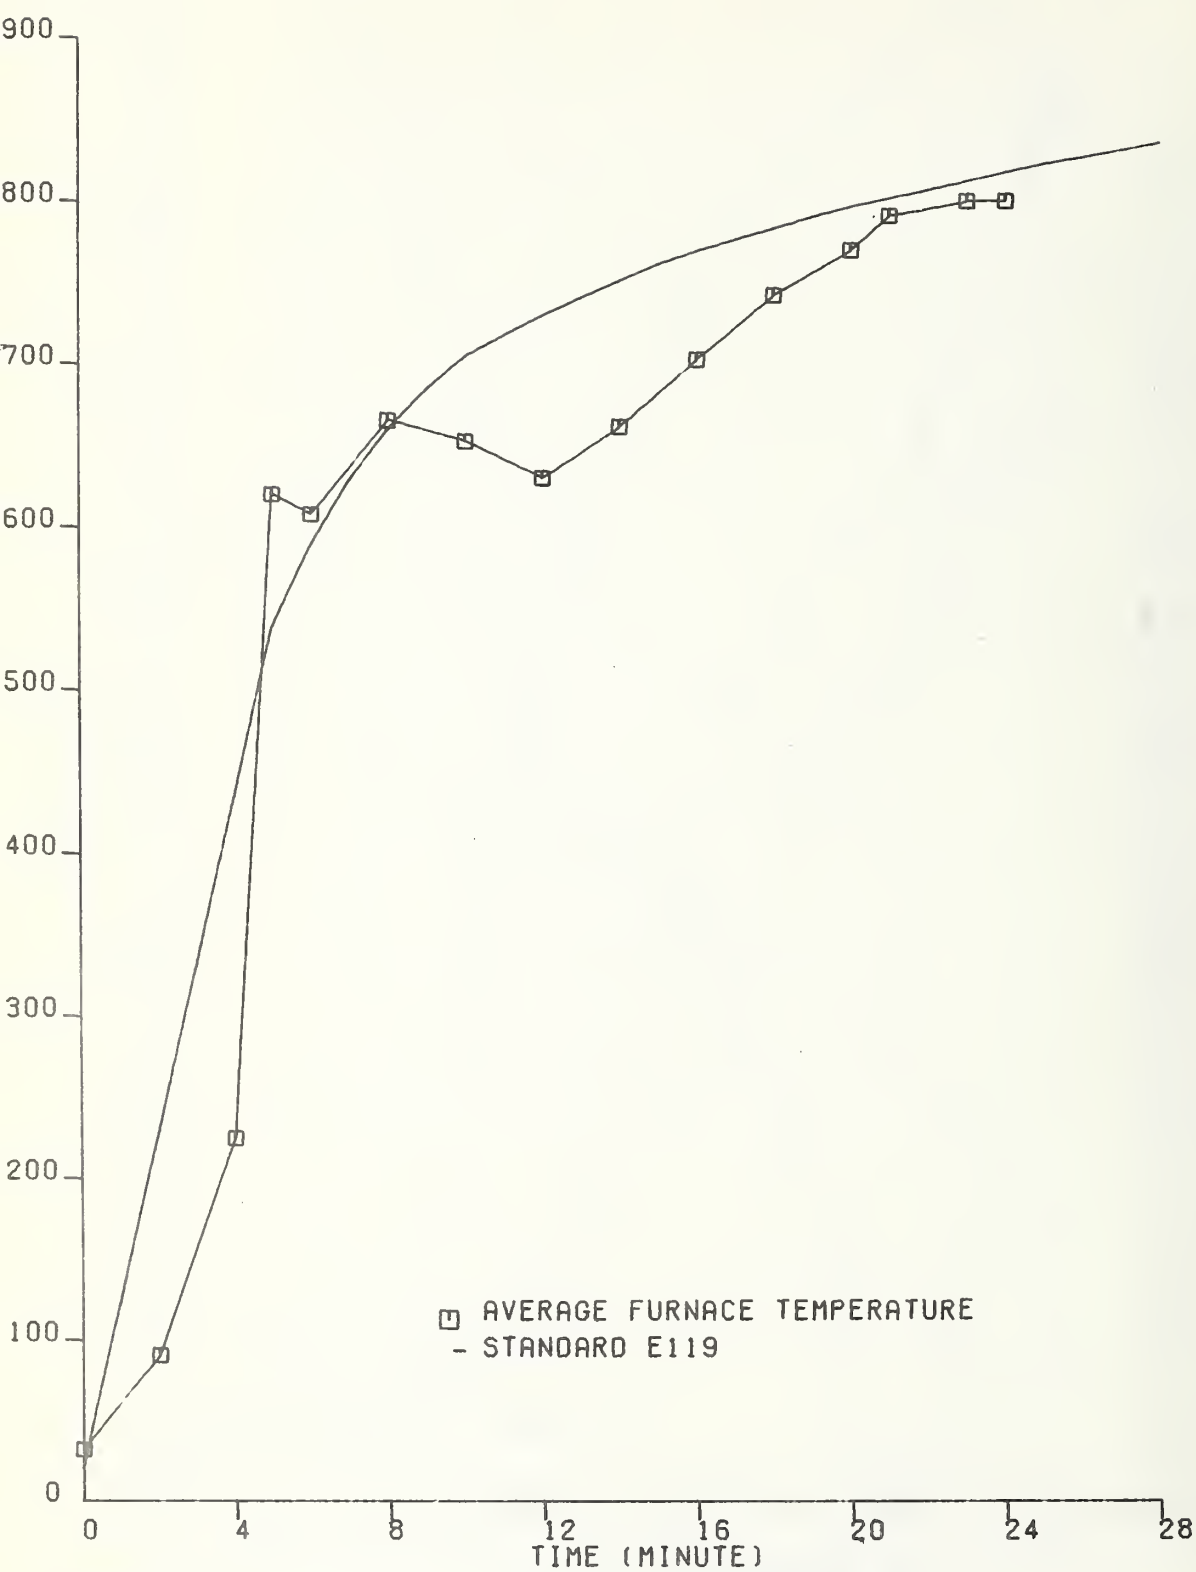
Figure 12.

The severity of the fire exposure in the wall assembly test was slightly below that prescribed by the standard time-temperature curve (Figure 12). According to the standard correction formula in ASTM E 119, based on the comparison of the areas under the actual time-temperature

AVERAGE FURNACE TEMPERATURE FOR WALL TEST COMPARED WITH STANDARD E119 TIME-TEMPERATURE CURVE
